NBSIR 82-2593

Investigation of Construction Failure of the Riley Road Interchange Ramp, East Chicago, Indiana

October 1982

N. J. Carino
H. S. Lew
W. C. Stone
R. M. Chung

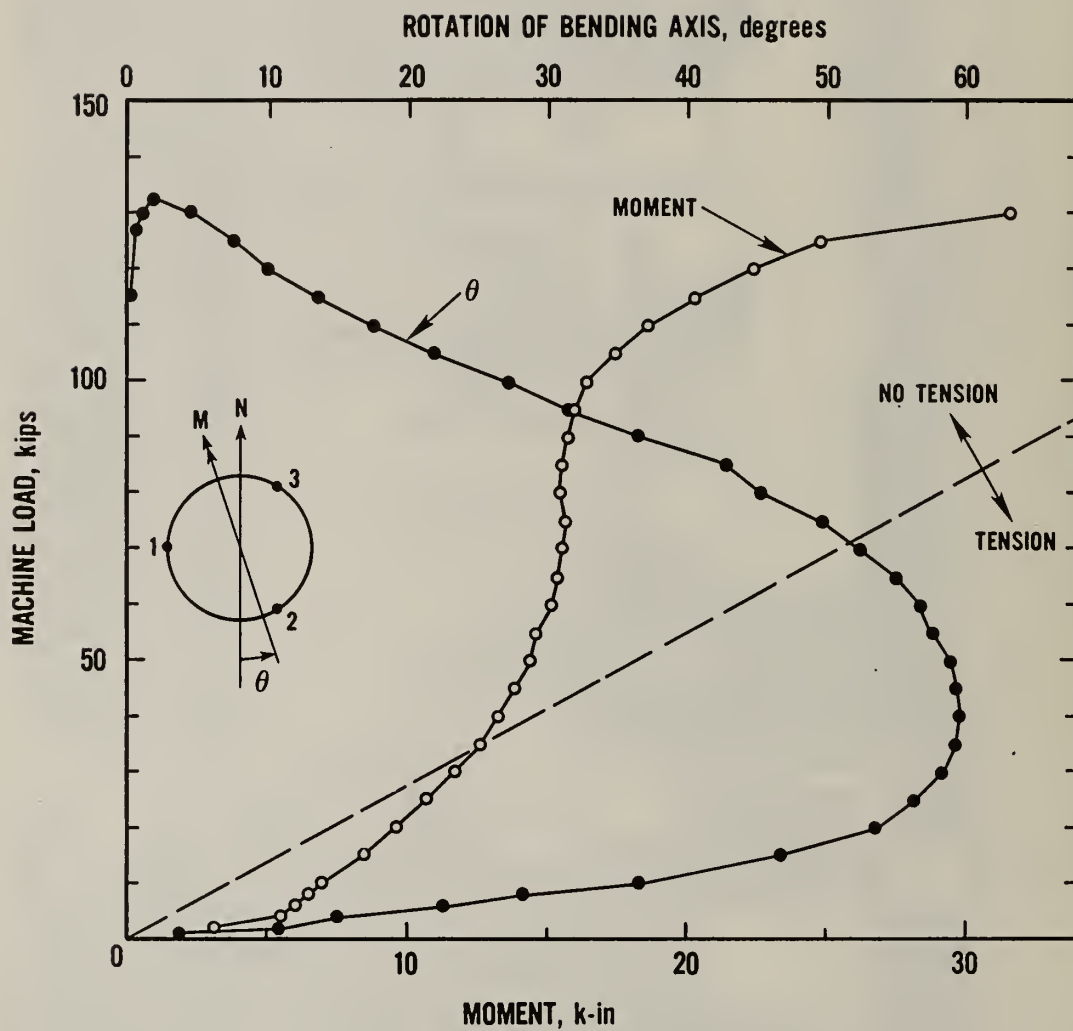
Figure 4.27 Variation of the magnitude and direction of the bending moment in the screw jack as a function of the vertical load (test #2)

As explained in section 4.4 (figures 4.27 and 4.30), in the falsework assembly tests the screw jacks experienced tensile strains only at low vertical loads. As the vertical load increased on the crossbeam, the tensile strains disappeared. The cross-section of the threaded bar remained in compression up to the maximum load. Furthermore, at the maximum load the relative displacement between the top and bottom flanges of the crossbeam was small, less than 1/2 in (12 mm). The maximum vertical loads (135 kips (600 kN) in test #2 and 120 kips (534 kN) in test #1) coincided with the onset of extensive yielding in the web of the crossbeam. These maximum loads are less than the elastic buckling strength of the crossbeam web noted in section 6.2.2. In the tests, the web was subjected to axial load plus out-of-plane bending moment, and the maximum load was attained when stresses due to the combined loading reached the yield strength.

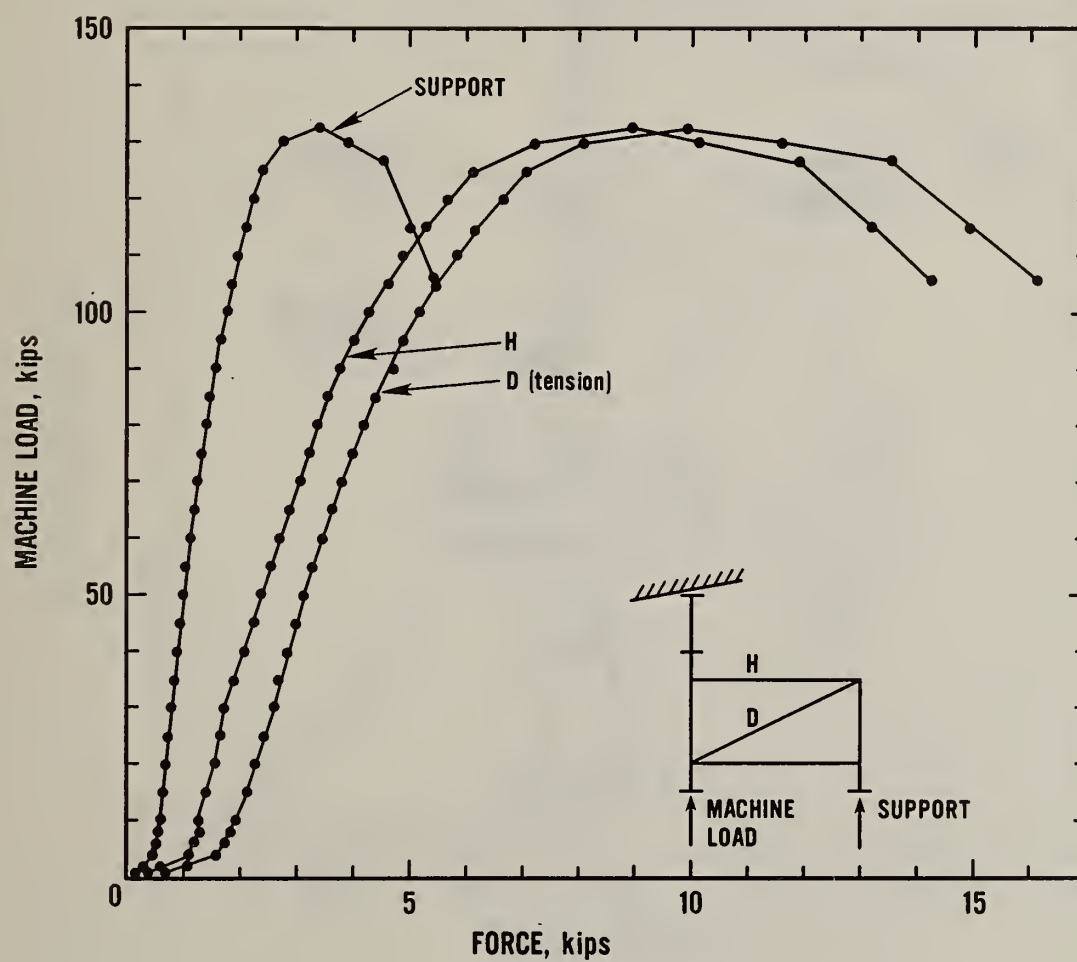
Figure 4.28 Variation of brace forces and support reaction as a function of vertical load (test #2)

Because of the lack of wedges between the longitudinal stringers and the supporting crossbeams, it has been determined from tests (see chapter 4) that horizontal forces are introduced into the upper screw jacks at the bottom of the crossbeams. As illustrated in figure 4.28, the magnitude of this horizontal force increases fairly linearly with increasing axial load until the onset of yielding in the web of the crossbeam. For a vertical load of 100 kips the horizontal force component was equal to at 2.4 kips (10.7 kN). This force, due to the geometry of the contact surface as evidenced in the deflected shapes of the tests (figure 4.29), would be directed parallel to the longitudinal axis of the bridge in an easterly direction (for unit IV). To account for this additional force in the analytical study, a mechanistic model as shown in figure 5.10 was employed. This transforms the vertical stringer reaction into an equivalent vertical load at the screw jack top, plus a horizontal component derived from a linear approximation of the experimentally measured loads. In falsework assembly test #2 the horizontal force was measured indirectly by the various strain gage and load cell elements which monitored forces in the horizontal and diagonal braces. The horizontal force at the screw jack was back

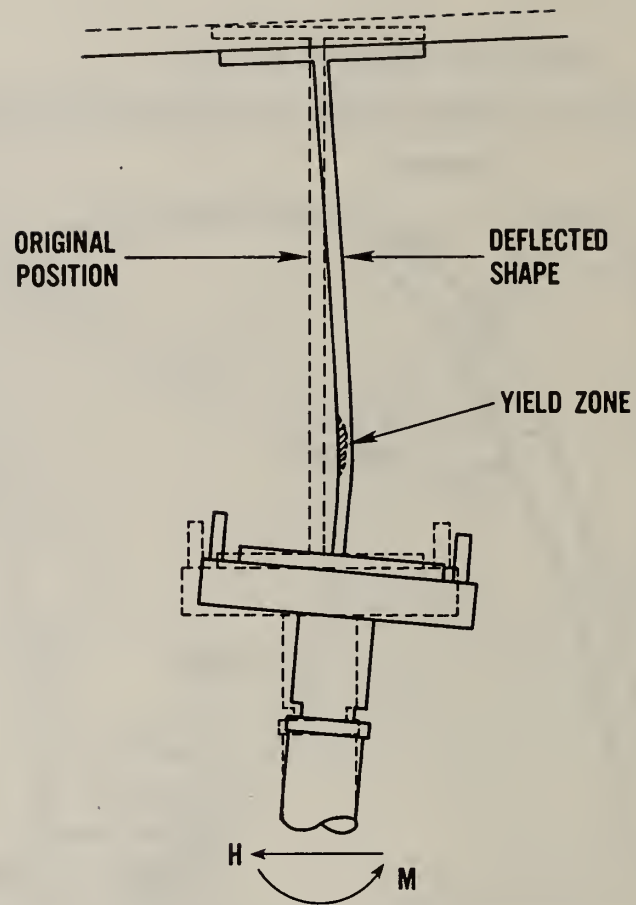
Figure 4.29 Schematic of deflected shape of crossbeam and top of U-head when wedges are not used between stringer and crossbeam

3.57 percent slope. A similar deformed shape of the web was also observed in the NBS laboratory tests (see figure 4.29). As the top of the tower moved toward the east, the bottom flanges of the crossbeams followed it; and the deformed shapes of the crossbeams would have progressively changed as shown by positions 2, 3, and 4. As illustrated in the figure, while the bottom flange translates, it also rotates and the curvature of the web changes. As a result, the direction of the bending moment on the U-heads also would have changed. The NBS falsework assembly tests did not show this change in curvature of the crossbeam web because the test setup was intended to investigate only the effects on the U-heads when wedges were not used between the stringer and crossbeam. While the bottom of the crossbeam translated in the tests, the rigidity of the test configuration did not allow the web of the crossbeam to change its curvature during the translation.

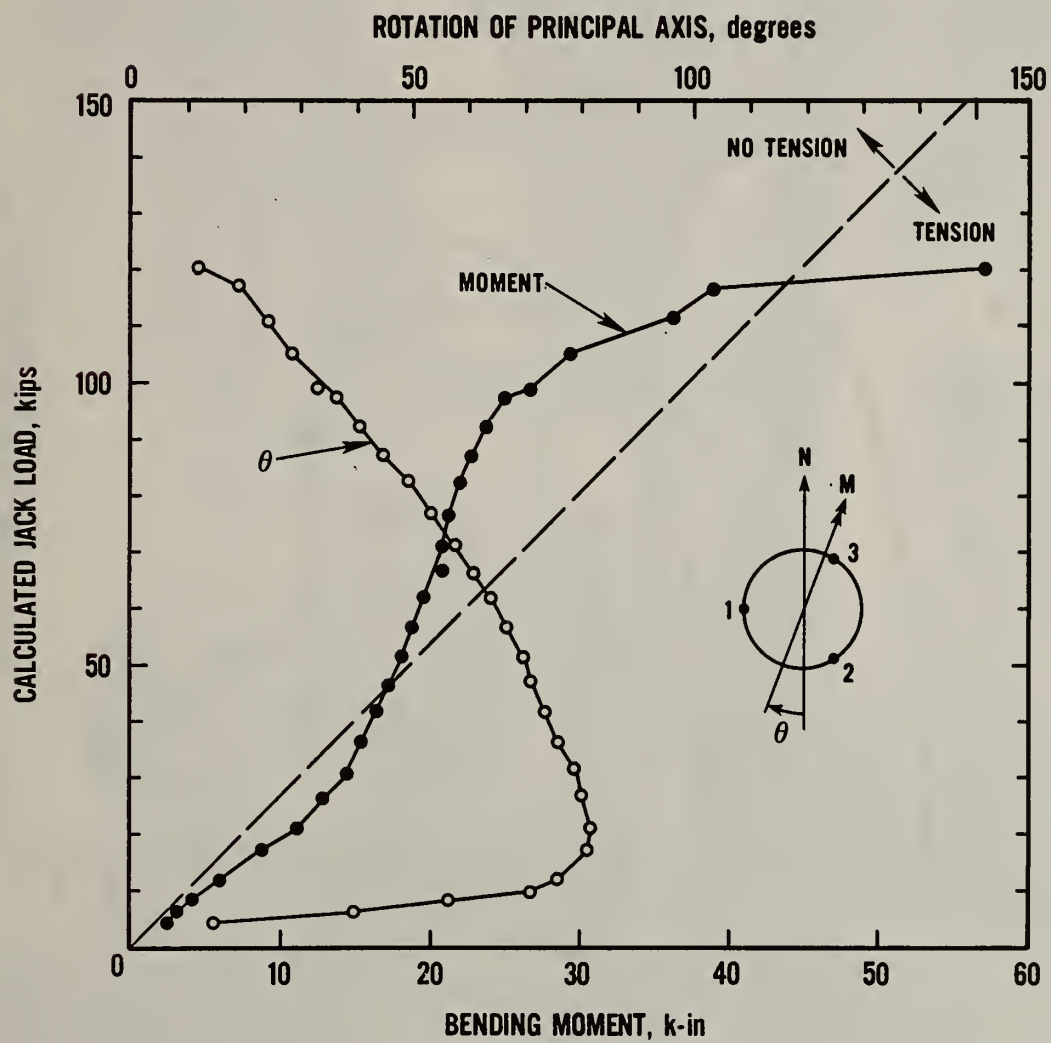
Figure 4.30 Variation of the magnitude and direction of the bending moment in the screw jack as a function of the vertical load (test #1)

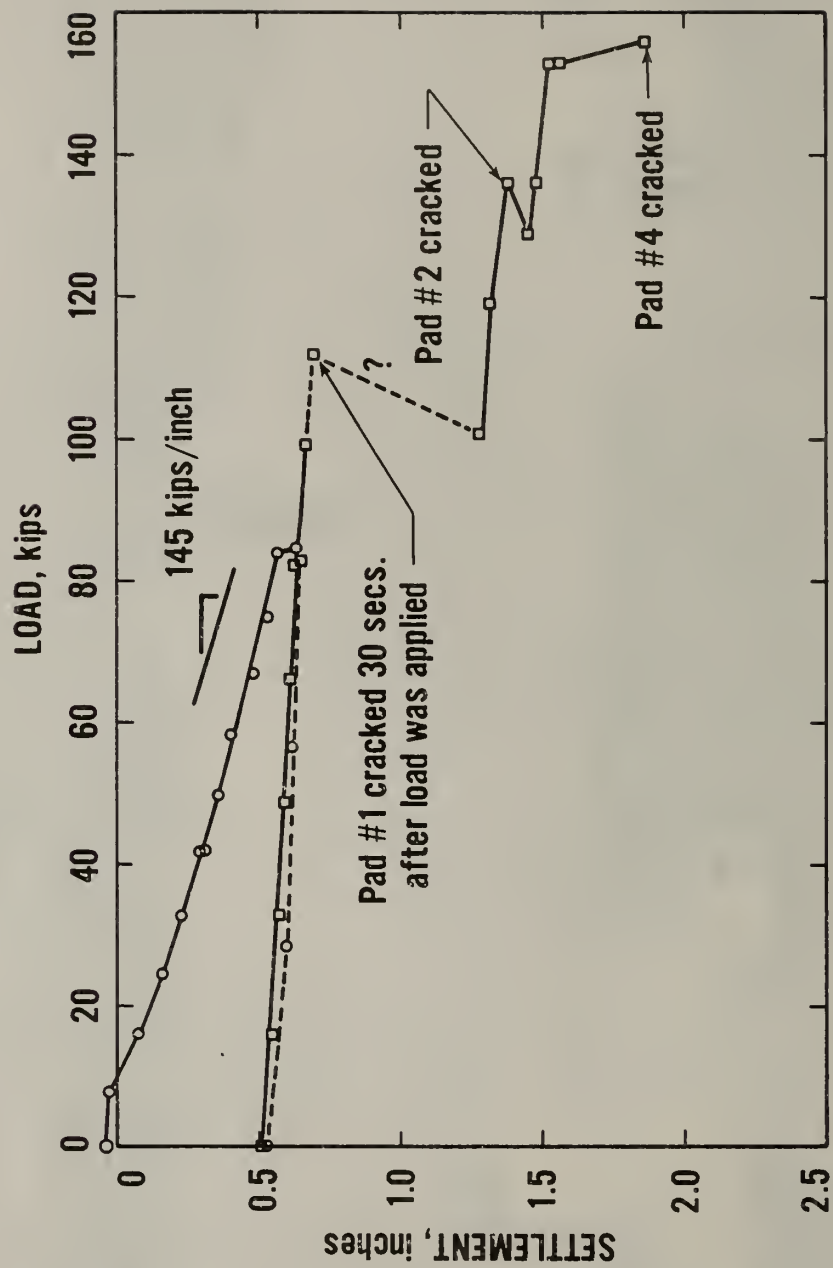
Load-displacement curves for the first pad to crack during each test are given in figures 4.43 through 4.45, for Tests 1, 2, and 3, respectively. The data presented in these figures were the readings recorded at dial #9, which measured the total settlement of the subsoil and the compacted slag in the sand box. Similar plots of the dial #9 readings for other pads are included in Appendix A. The circles are the data for load cycle 1 and the squares are for load cycle 2.

Common features which can be observed from Tests 1 and 2 are summarized as follows: for practical purposes the loading portion of load cycle 1 can be approximated as a straight line in the load range from 30 to 85 kips (134 to 378 kN). The loading curves of cycle 1 from Test 1, conducted in the area which had been precompacted during construction, indicated about 30 percent greater stiffness than from Test 2 which was conducted in an area of less previous compaction. Another common observation is that the pads could take additional load even after they had cracked. This, however, was not the case for pad 2 of Test 3, whose load-displacement curve is given in figure 4.45. In this case, and also for the other pads in Test 3, the pad could not support additional load once it had cracked. This is attributed to bearing failure of the shallow boiler slag layer underneath the pad. The boiler-slag would simply be pushed away by the cracked pad when the load was being re-applied and the pad continued to sink into the boiler slag. The loading portion of load cycle 1 for pad 2 of Test 3 also indicated an approximately linear relationship between the load and displacement; however the foundation was more compressible than observed in Test 2.

Figure 4.43 Load-displacement curves of screw jack base for pad 1 of Test 1

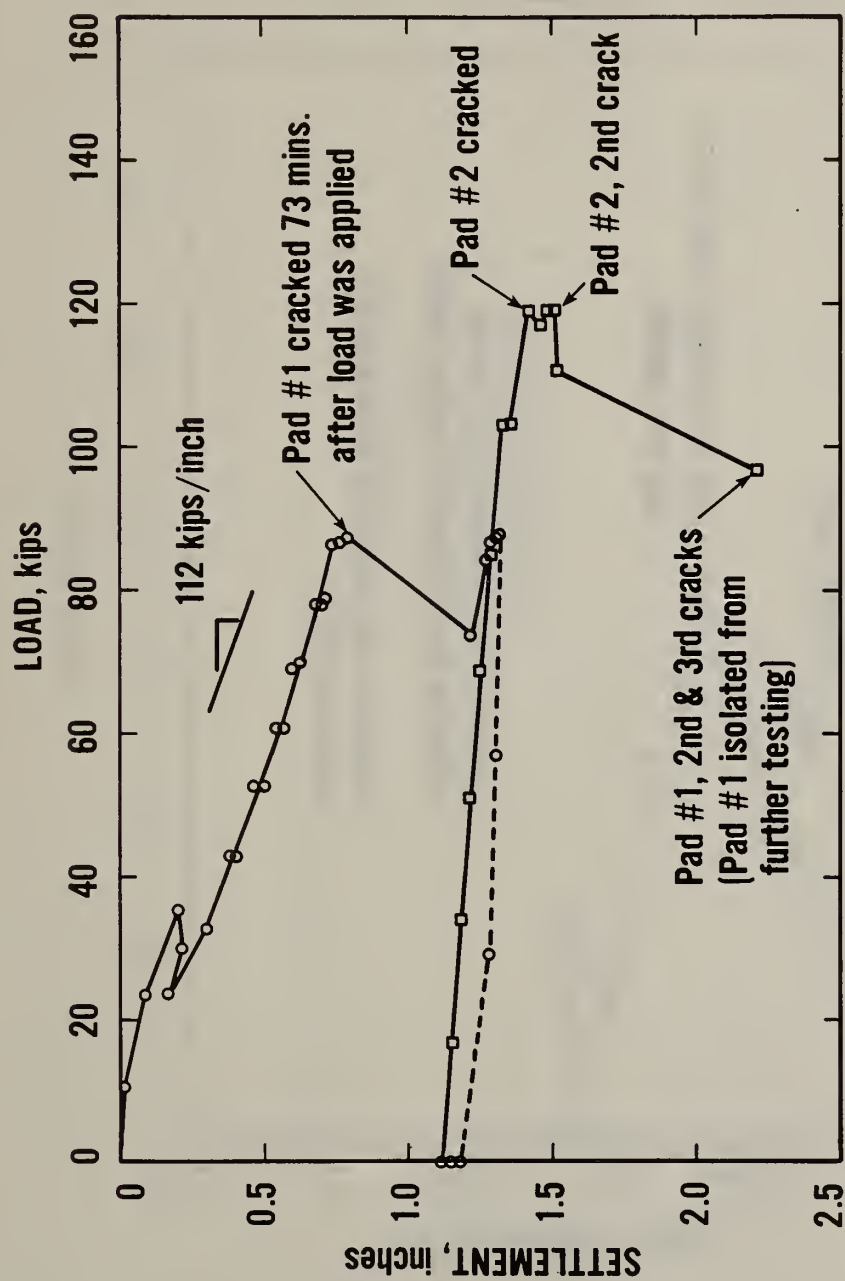
Figure 4.44 Load-displacement curves of screw jack base for pad 1 of Test 2

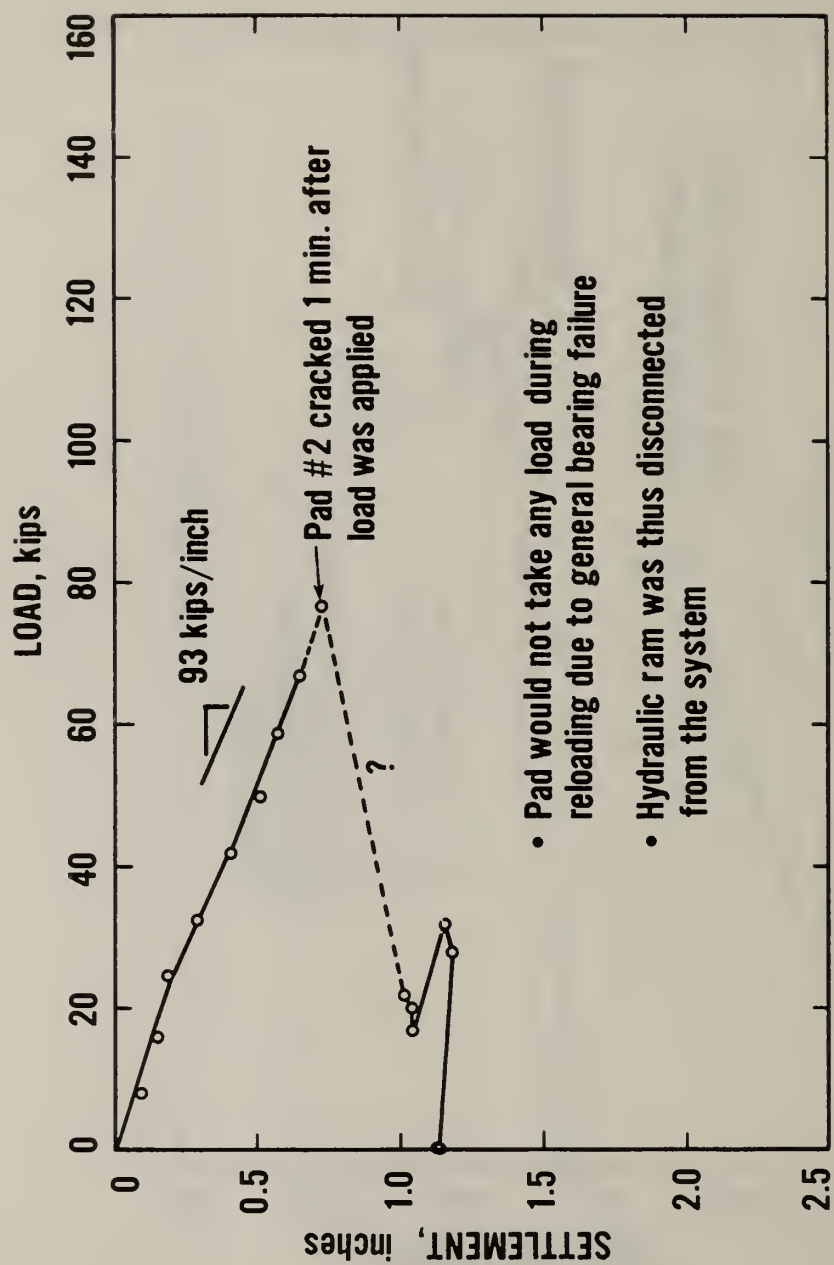
Figure 4.45 Load-displacement curves of screw jack base for pad 2 of Test 3

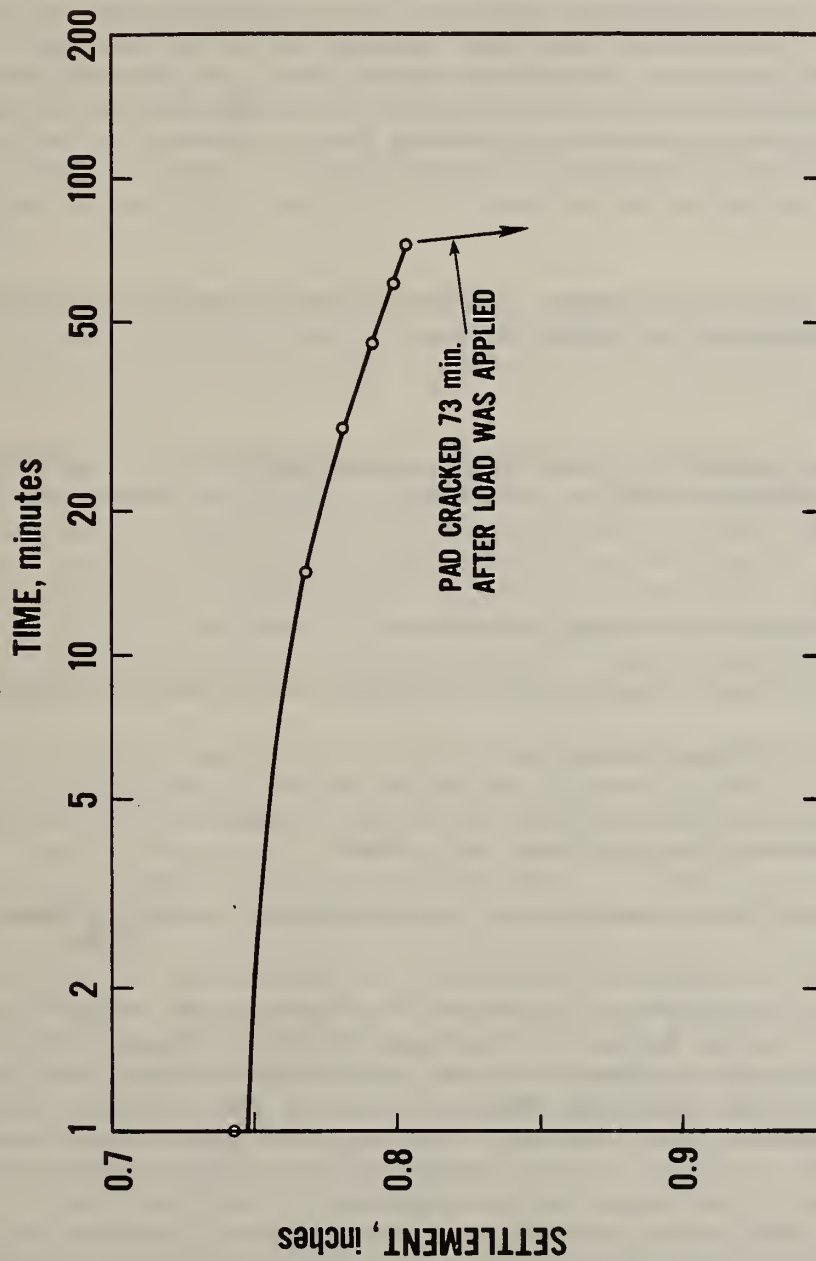
Table 4.4 also gives the duration of the constant load period when the pad cracked. Most pads cracked less than 10 minutes into the holding period. Three of the pads had a sudden failure as the load was being increased, and one pad (pad 1 of Test 2) cracked after the load had been maintained for more than one hour. Two factors are offered in an attempt to explain this delayed failure. Figure 4.46 shows the time-settlement curve obtained from pad 1 in Load

Figure 4.46 Time-settlement curve of screw jack base for pad 1 of Test 2

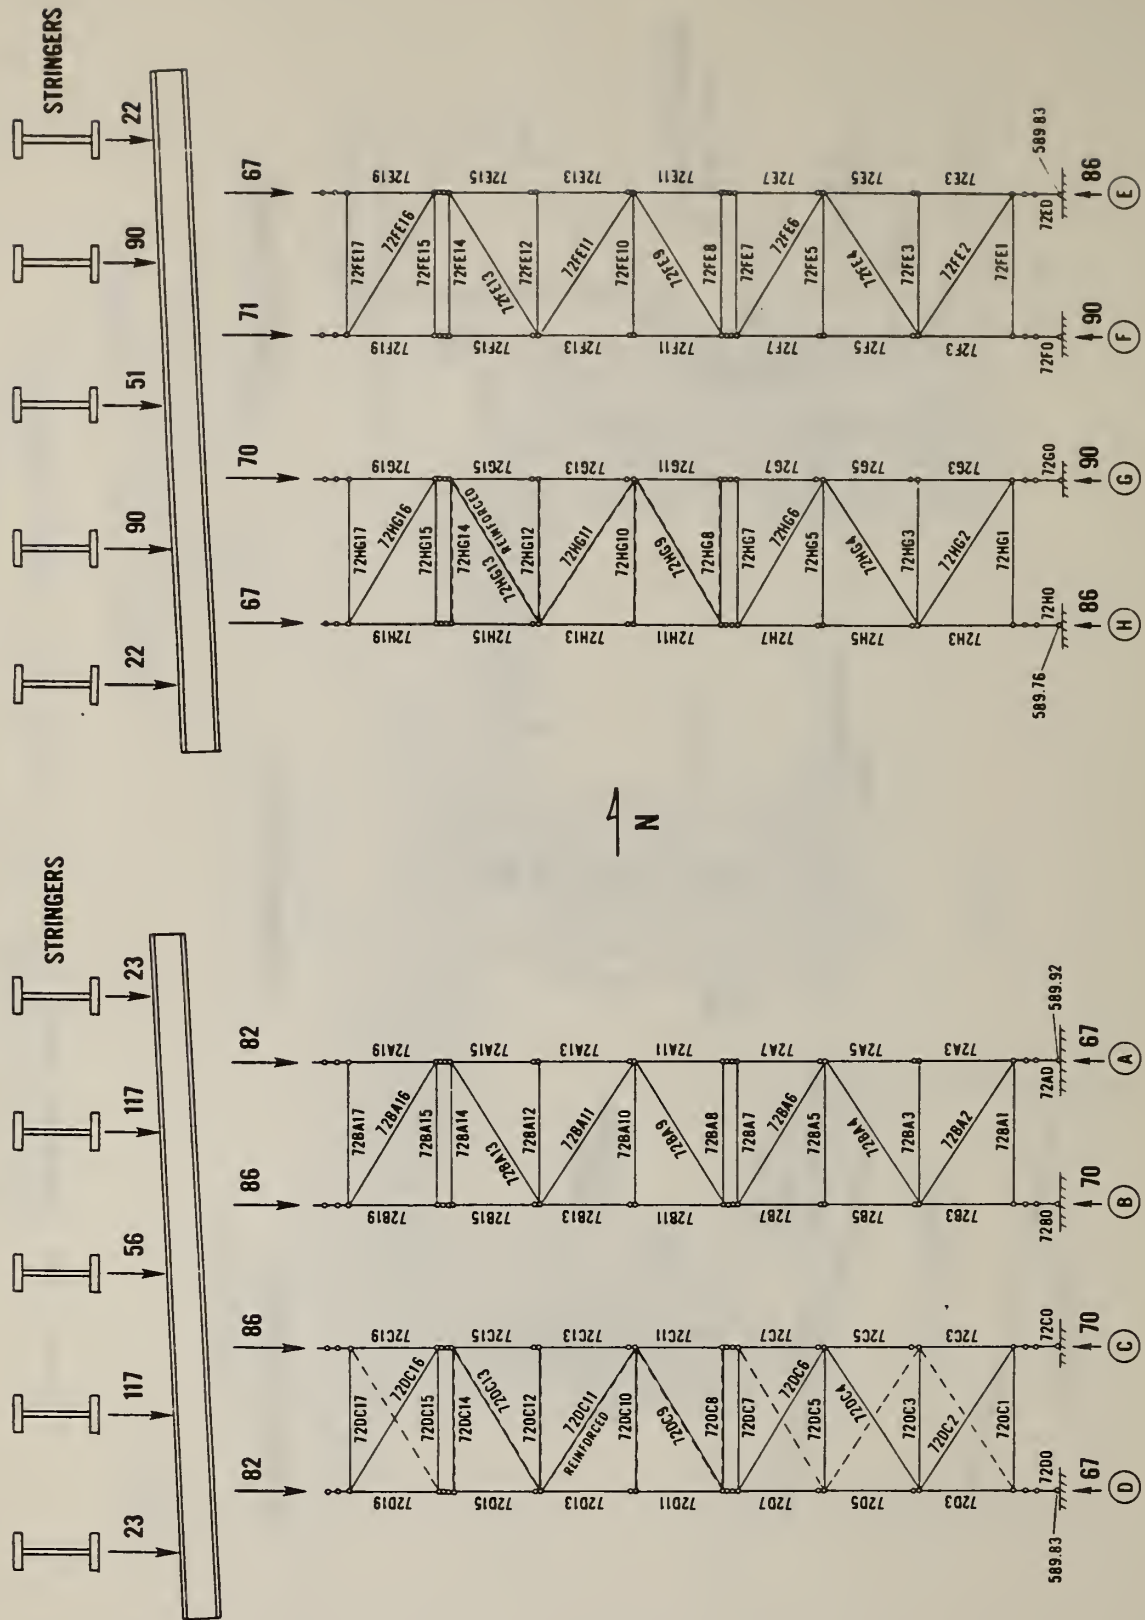
Figure 5.11 Stringers, crossbeam, and support reactions for towers at 407.2, for Case I plus Case II loadings (kips)

W36 x 194 section and 117 kips (521 kN) for the W36 x 260 section (see fig. 5.11). These two different reactions result from the continuity of the concrete box girder over the two supports provided by the shoring towers. When these moment and reaction values due to construction loads are compared with the AISC allowable values of the two stringer cross sections, it is found that the allowable strength values exceed the maximum applied moment and reactions by large margins. The shear capacities of the webs were also computed and they were found to be far in excess of the shear resulting from the applied loads.

Using a nominal yield strength of 36 ksi (350 MPa), the AISC allowable shear capacity of a W24 x 68 section is 135 kips (600 kN). This value is substantially greater than maximum shear of 59 kips (260 kN) occurring between stringer S2 of span 8.0 and the U-head reaction at leg A as shown in figure 5.11.

In accordance with the AISC Specification, the maximum concentrated load that a W24 x 68 section can support without crippling of the web due to a localized force is 276 kips (1230 kN). This capacity is about 2.34 times the maximum stringer reaction of 117 kips (521 kN) (see figure 5.11).

The maximum loads in the falsework assembly tests are greater than the maximum computed load of 86 kips (383 kN) on the U-heads at legs B and C (see figure 5.11). The failure of the falsework assembly was governed by the strength of the crossbeam rather than by the strength of the U-head. This observation suggests that U-heads would not have failed under the applied loads. Thus, it is unlikely that a U-head failure initiated the collapse of unit IV.

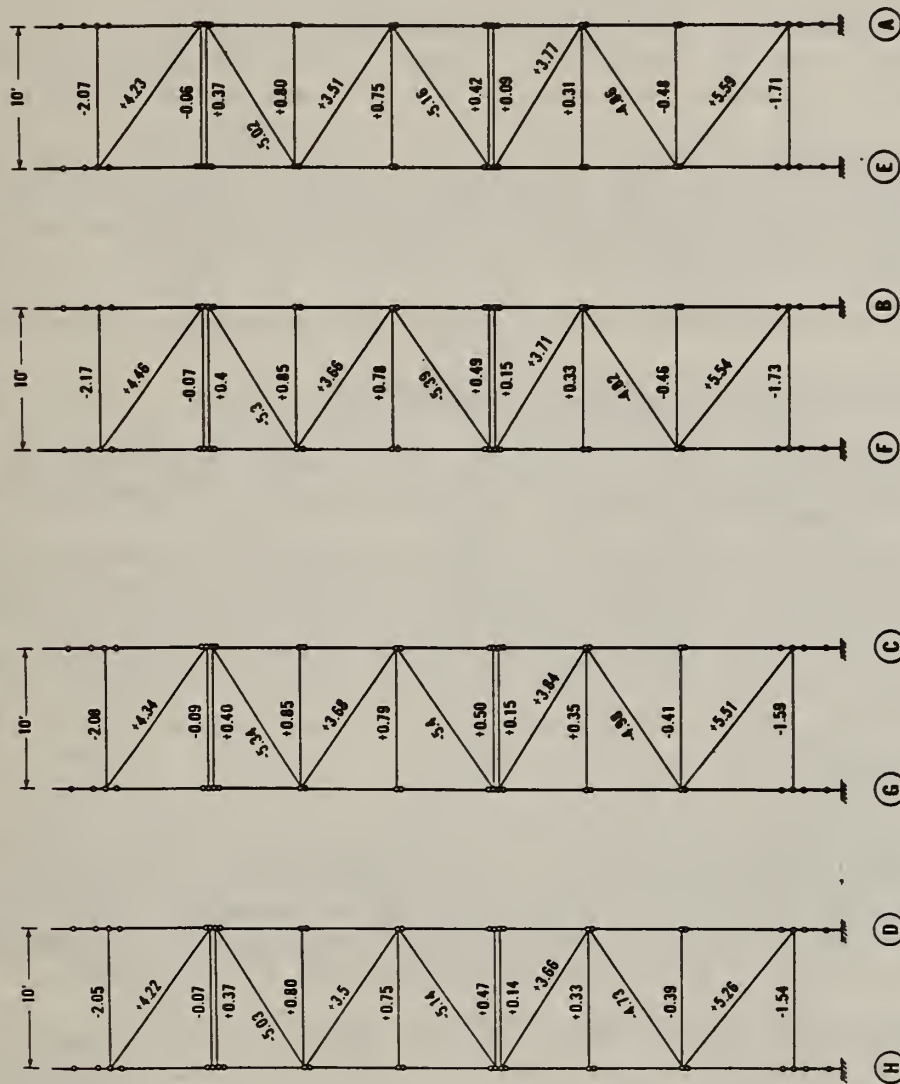
Figure 5.12 Truss brace forces for towers at 407.2 for Case I plus Case II loadings (kips)

When the magnitudes of the computed forces in the bracing members are compared with the average strengths, both in tension and compression, it is found that the forces are less than these strengths (see fig. 5.12). However, the computed compressive forces in some of the diagonal members in trusses BF and CG at 407.2 were either equal to or slightly greater than the lowest compressive test value of 5.3 kips (23.6 kN). It should be noted that this low value was attributed to corrosion in a confined area of the tube rather than to an overall small cross-sectional area. In order to examine the consequences of a possible failure of these highly loaded diagonal members, an analysis was made for the Case II loading with these members removed. The results showed that force redistribution took place and the overall stability of the tower was not affected by the removal of the diagonals. Since in the real structure members would not immediately lose their load carrying capacity upon reaching their buckling loads, the analysis with the diagonal members removed represents a severe condition. Thus, it is unlikely that bracing members failed in tension, and it is unlikely that any diagonal members which might have buckled would have triggered the collapse of the falsework at 407.2.

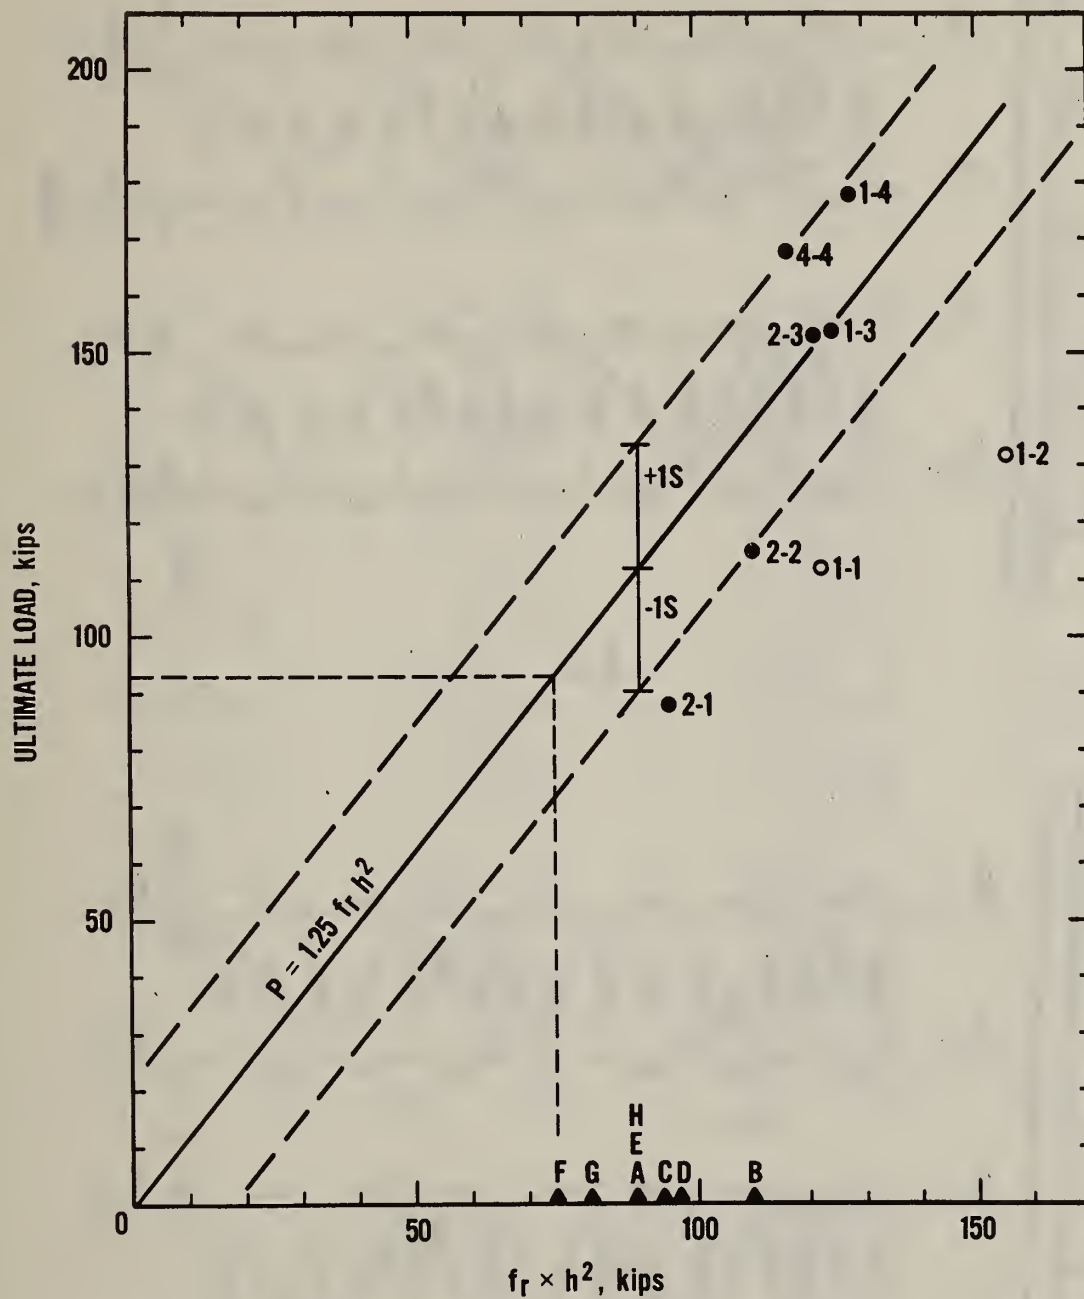
where f_r is the modulus of rupture of the concrete and h is the thickness of the pad. Figure 6.1 shows the results of the full-scale load tests. The ordinate is the observed cracking load of the pad (table 4.4) and the abscissa is $f_r \cdot h^2$. The modulus of rupture was estimated from the average compressive strength, f_c , of the cores taken from the tested pads (table 4.5) using the accepted expression $f_r = 7.5 \sqrt{f_c}$ [6.6]. The pad thickness, h , is based on the average length of the untrimmed cores. Also shown, figure 6.1 is the line representing eq. (6.1), which coincides with the regression line fitted through the origin, excluding the data points 1-2 and 1-1. It is seen the theoretical expression (eq. 6.1) represents the experimental values reasonably well, the residual standard deviation of the line is 22 kips (98 kN). The concrete pads used for the full-scale load tests were previously used to support shoring towers in other portions of the ramp and some were impacted by falling debris during the collapse. Thus, some of the pads could have suffered internal damage which was not discernible. It is believed that the lower than expected strength of pads 1-1 and 1-2 can be attributed to previous damage of the pads.

The values of $f_r \times h^2$ for pads A through H of the towers at 407.2 are plotted on the abscissa of figure 6.1. These values are computed based on the average strengths and untrimmed lengths of the cores reported in table 4.6. Although the actual strength of the individual pads could deviate from the straight line $P = 1.25 f_r h^2$, this line is an available means to estimate the expected pad cracking strength. For example, the expected strength for pad F is 94 kips (418 kN) and for pad E it is 109 kips (485 kN). From this figure and the tower leg reactions shown in figure 5.11, it can be concluded that any of pads E, F, G, and H could have been a candidate for cracking when the possible scatter of

actual strength values about the prediction line is taken into consideration. The structural analysis showed that pads F and G at 407.2 were the most heavily loaded pads, each carrying 90 kips (400 kN). As indicated above, the expected capacity of pad F is 94 kips (418 kN), and figure 6.1 indicates that the expected capacity of pad G is about 100 kips (445 kN). Thus, it is reasonable to conclude that one of the pads E through H cracked, with pad F having the highest likelihood of being the first to crack.

Figure 6.1 Cracking loads of concrete pads in field tests vs. $(f_r \times h^2)$

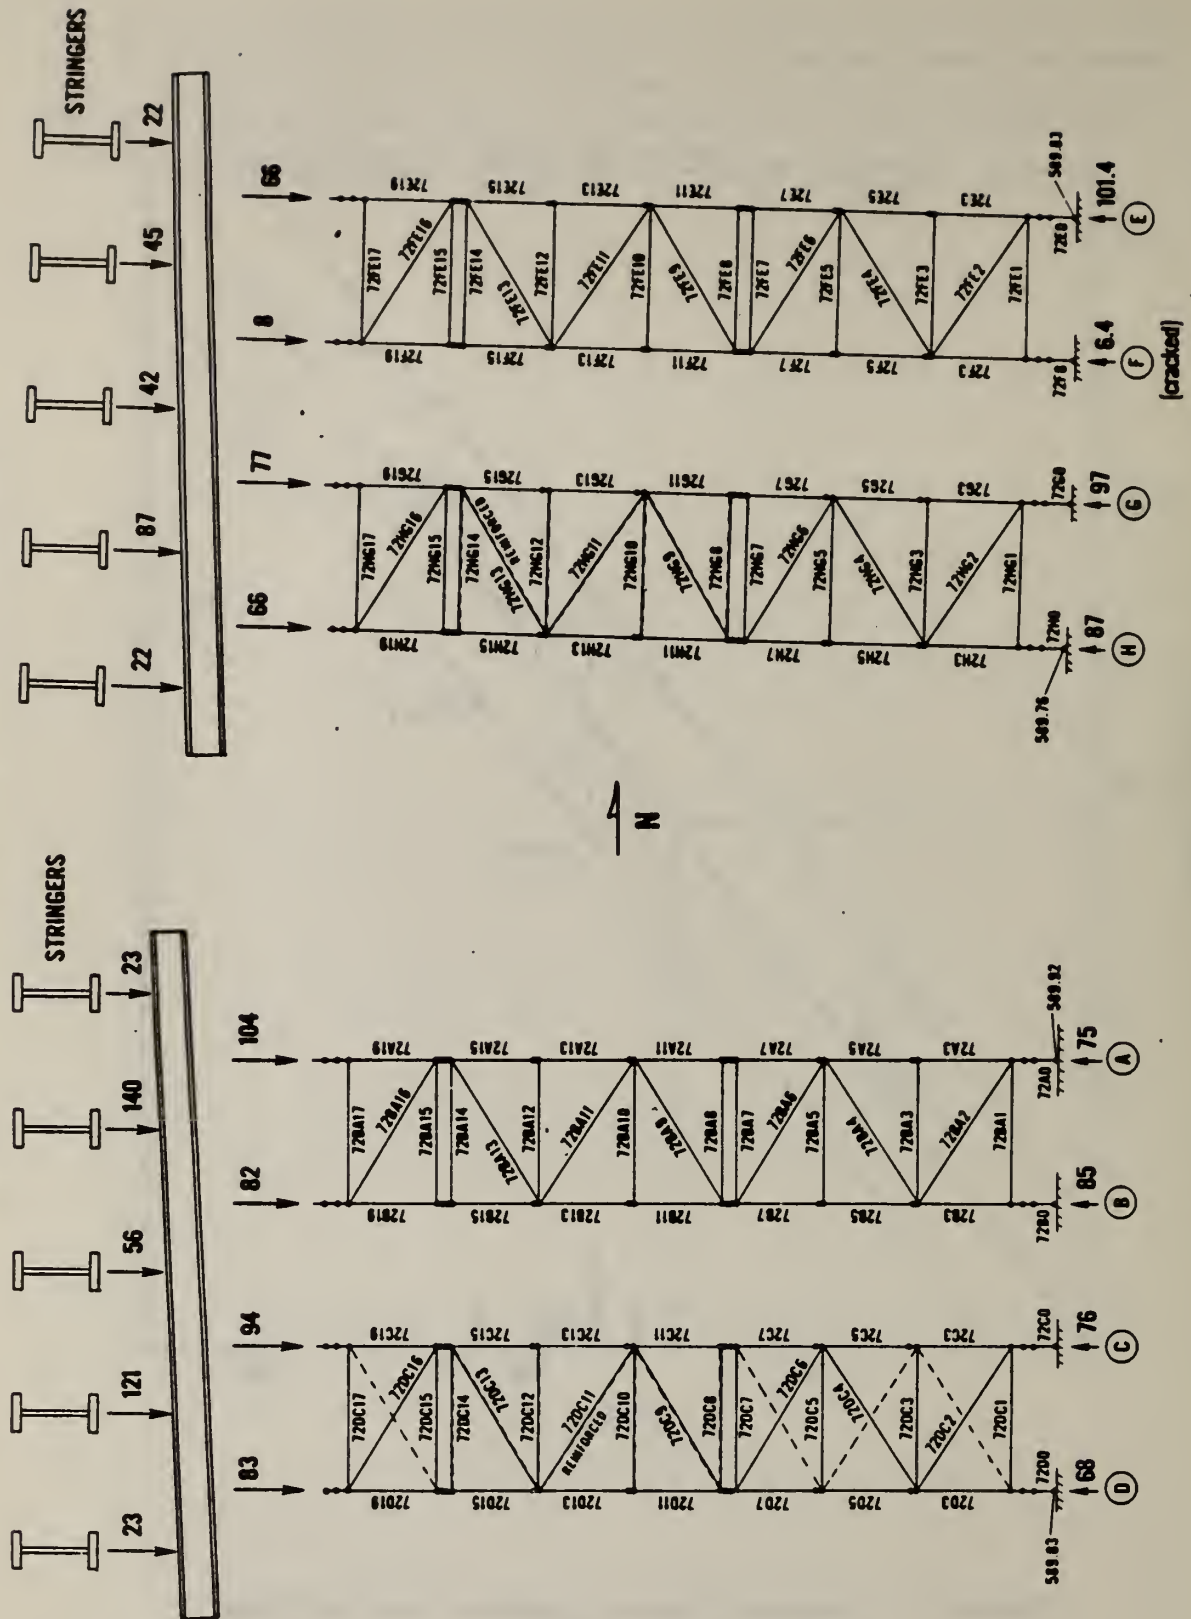
Figure 6.2 Stringer, crossbeam, and support reactions for towers at 407.2 with support settlement of 0.4 in at pad F

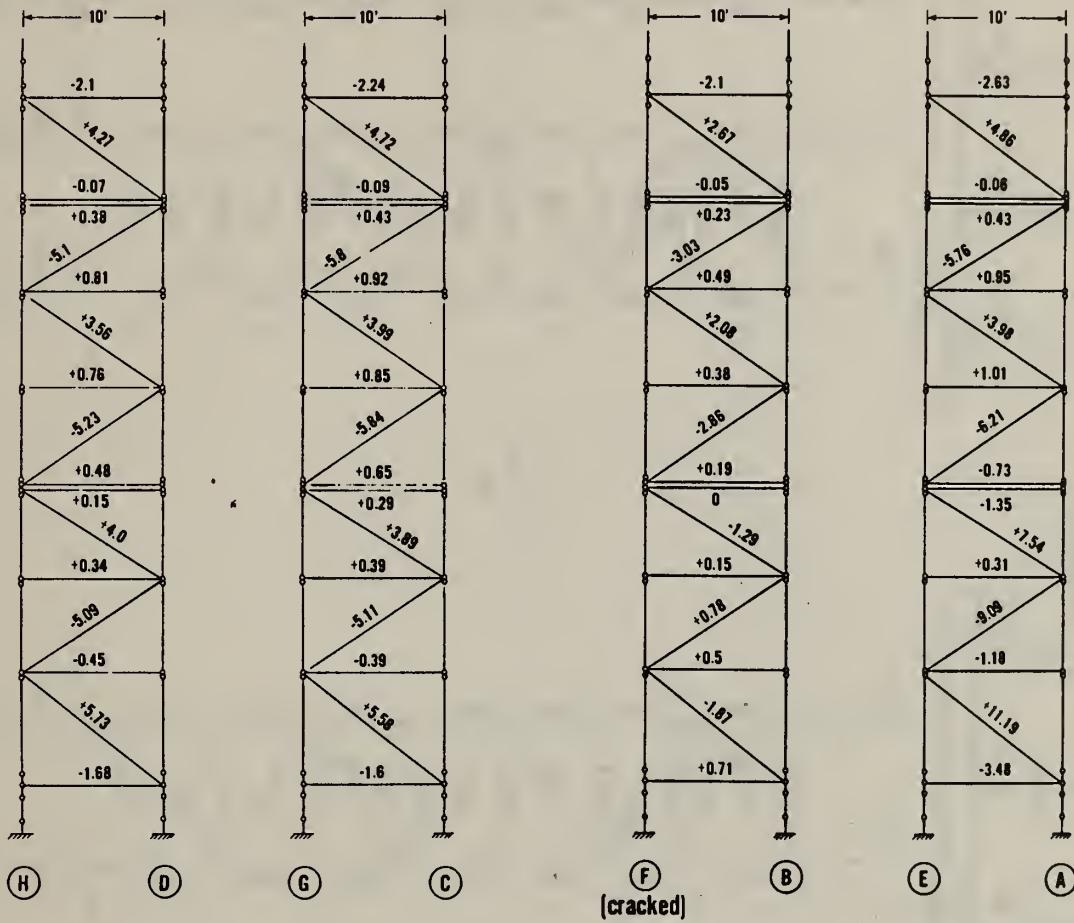
Figure 6.3 Truss brace forces for towers at 407.2 with support settlement of 0.4 in at pad F

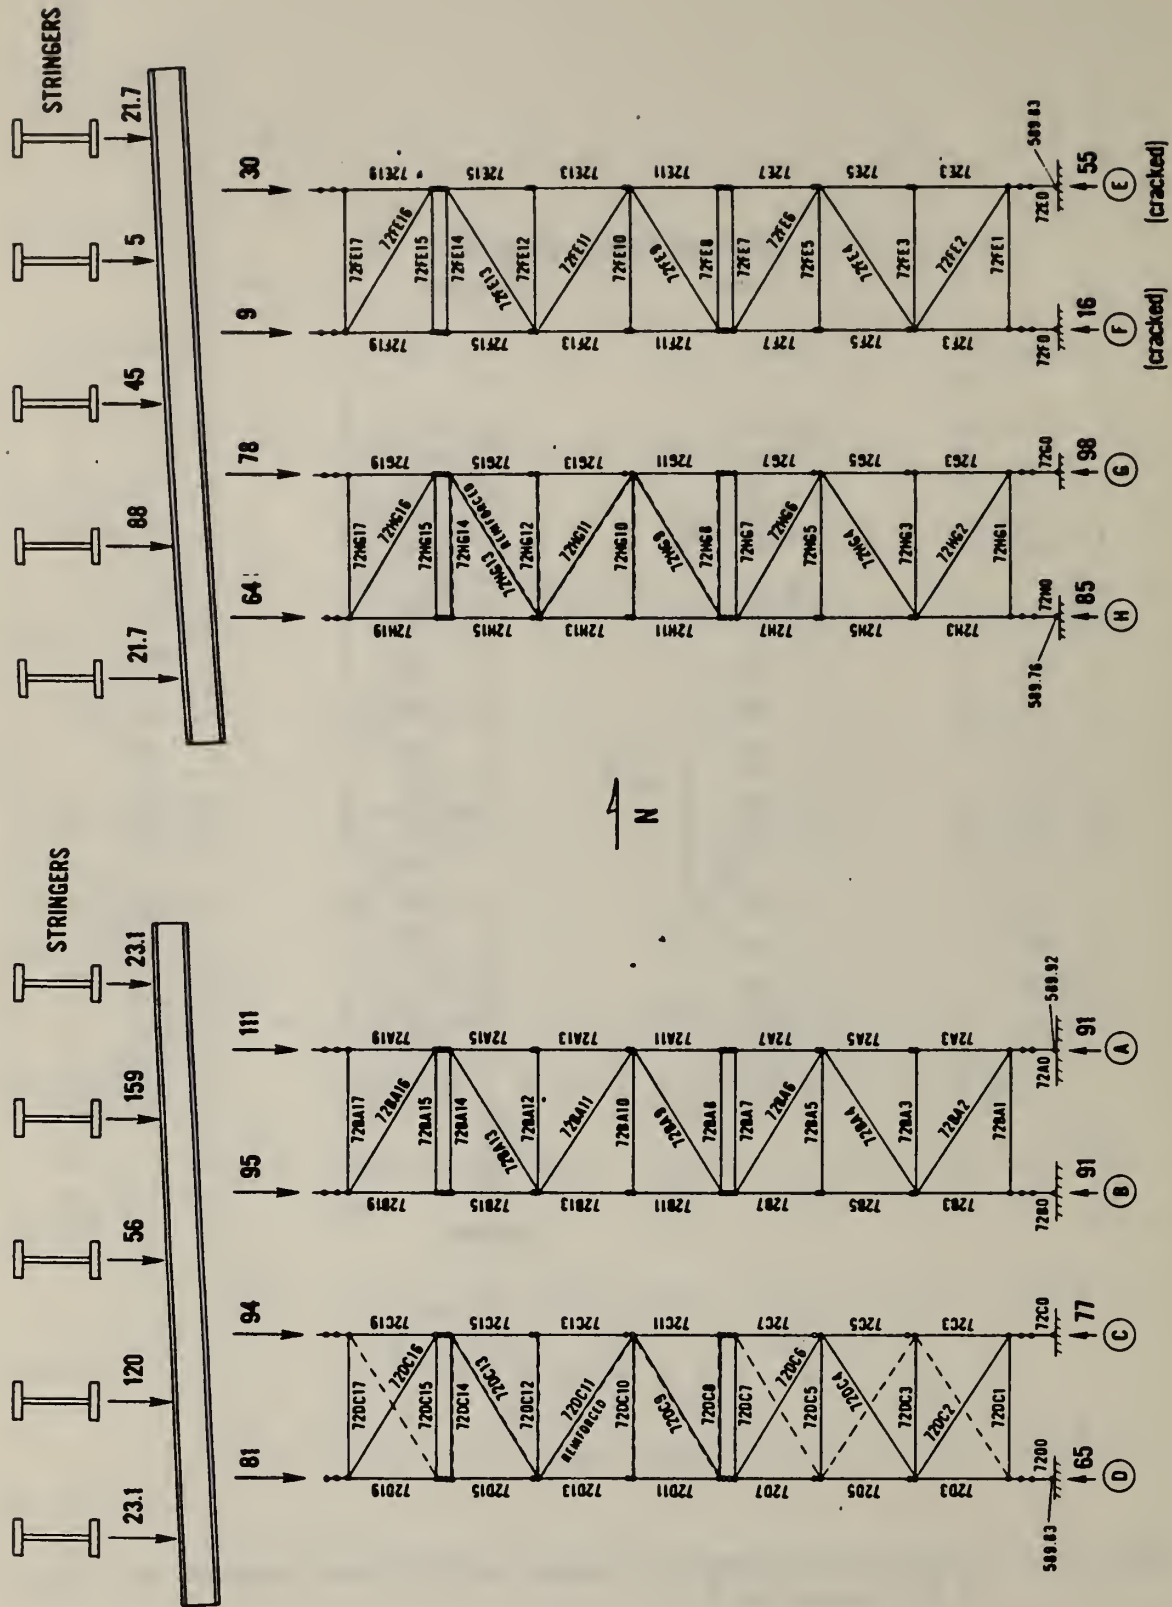
Figure 6.4 Stringer, crossbeam, and support reactions for towers at 407.2 with support settlement of 0.4 in at pads E and F and buckled diagonal 72EA4

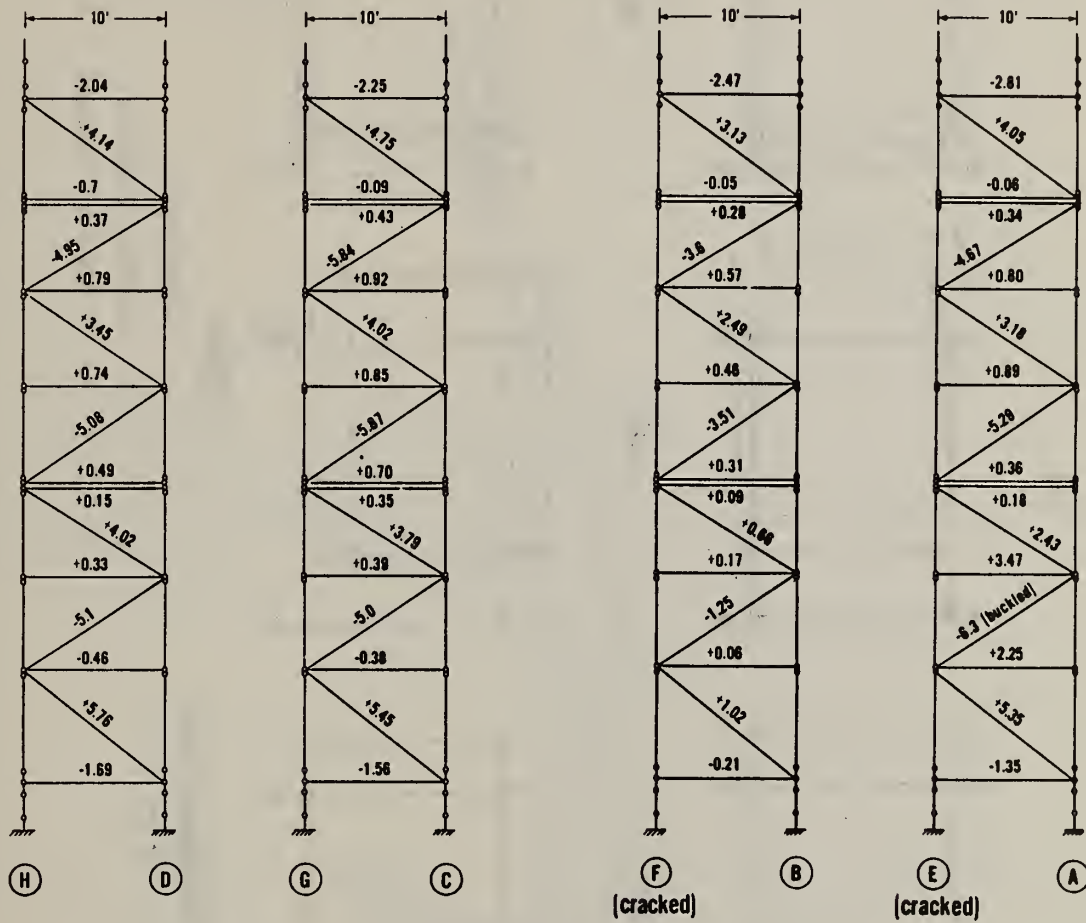
Figure 6.5 Truss brace forces for tower 407.2 with support settlement of 0.4 in at pads E and F and buckled diagonal 72EA4

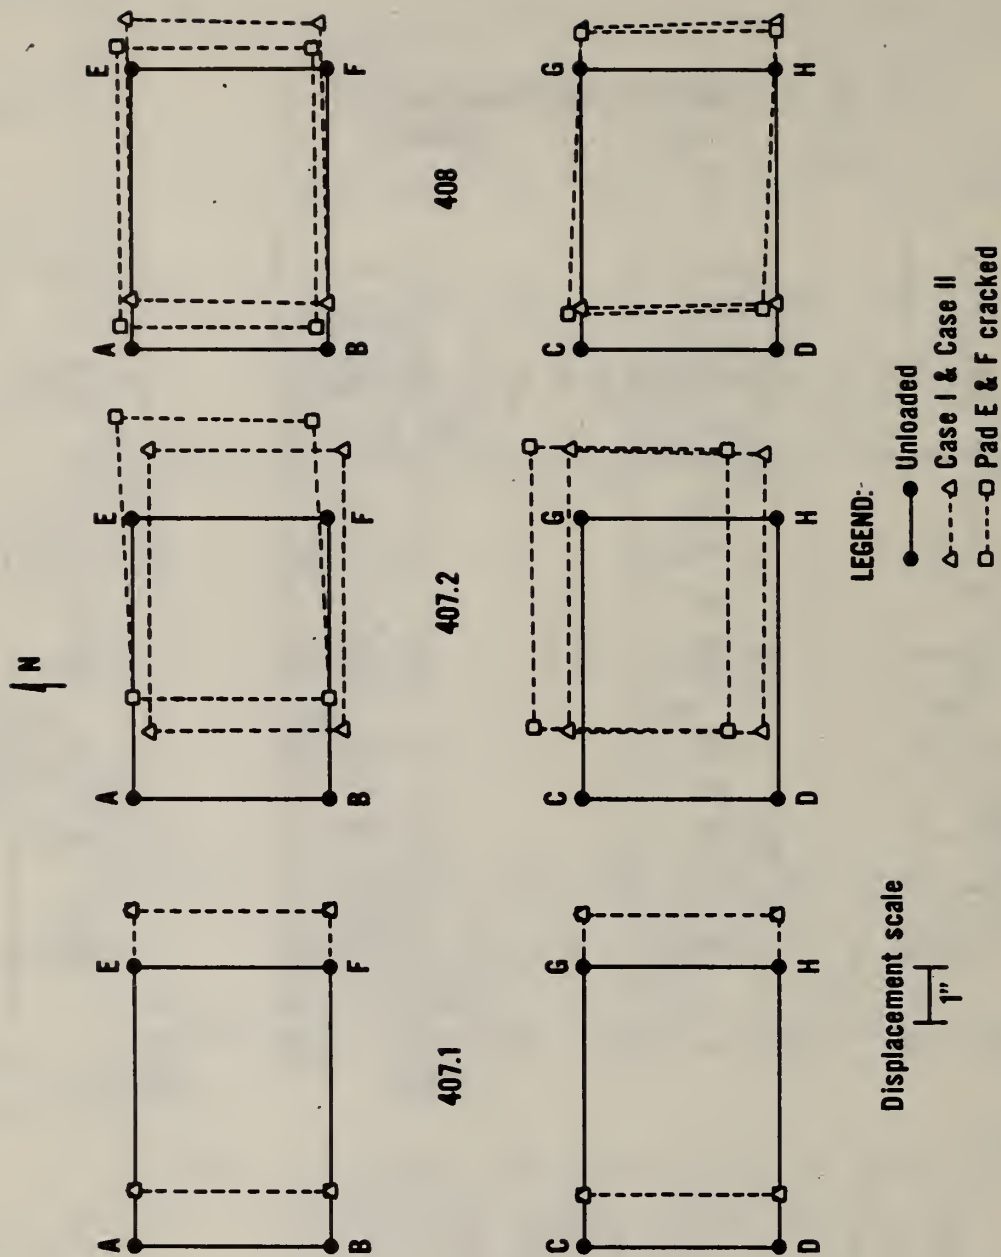
Figure 6.6 Lateral displacements of top of shoring towers
